Harry S Truman National Historic Site

Truman Home HS-01
Truman Carriage House HS-02

Historic Structures Report

Architectural Data Section
Existing Condition Drawings

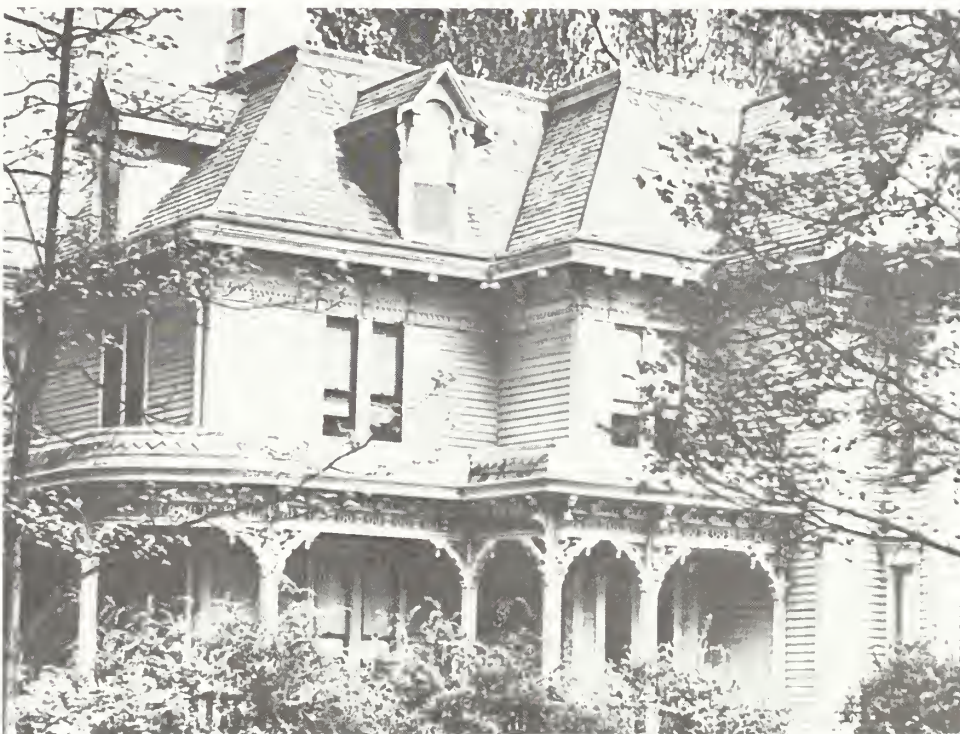
Fig. 1.9 Truman Home, July 22, 1944. West elevation (looking southeast). Detail showing condition of home prior to 1945 renovation. Credit: HSTL

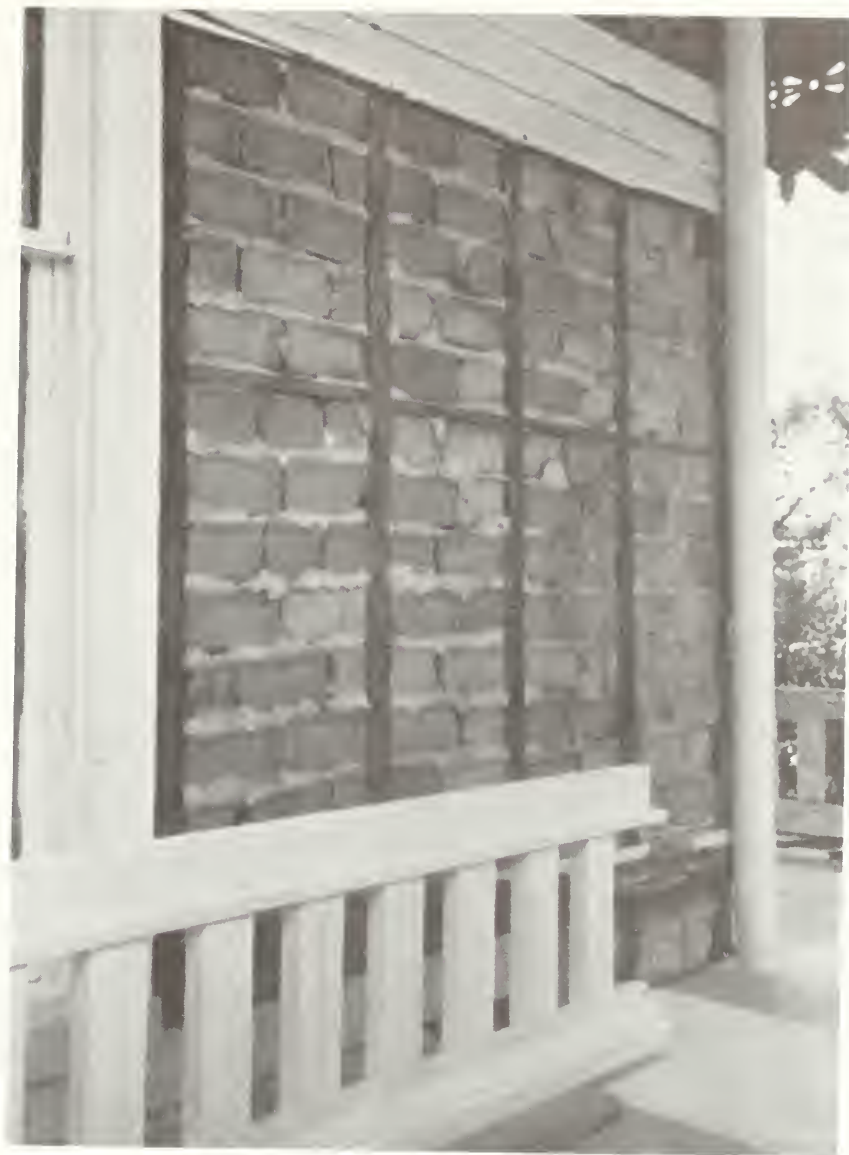
Fig. 2.6 Brick Nogging, Truman Home. North elevation, July 1984. Credit: National Park Service, Midwest Region

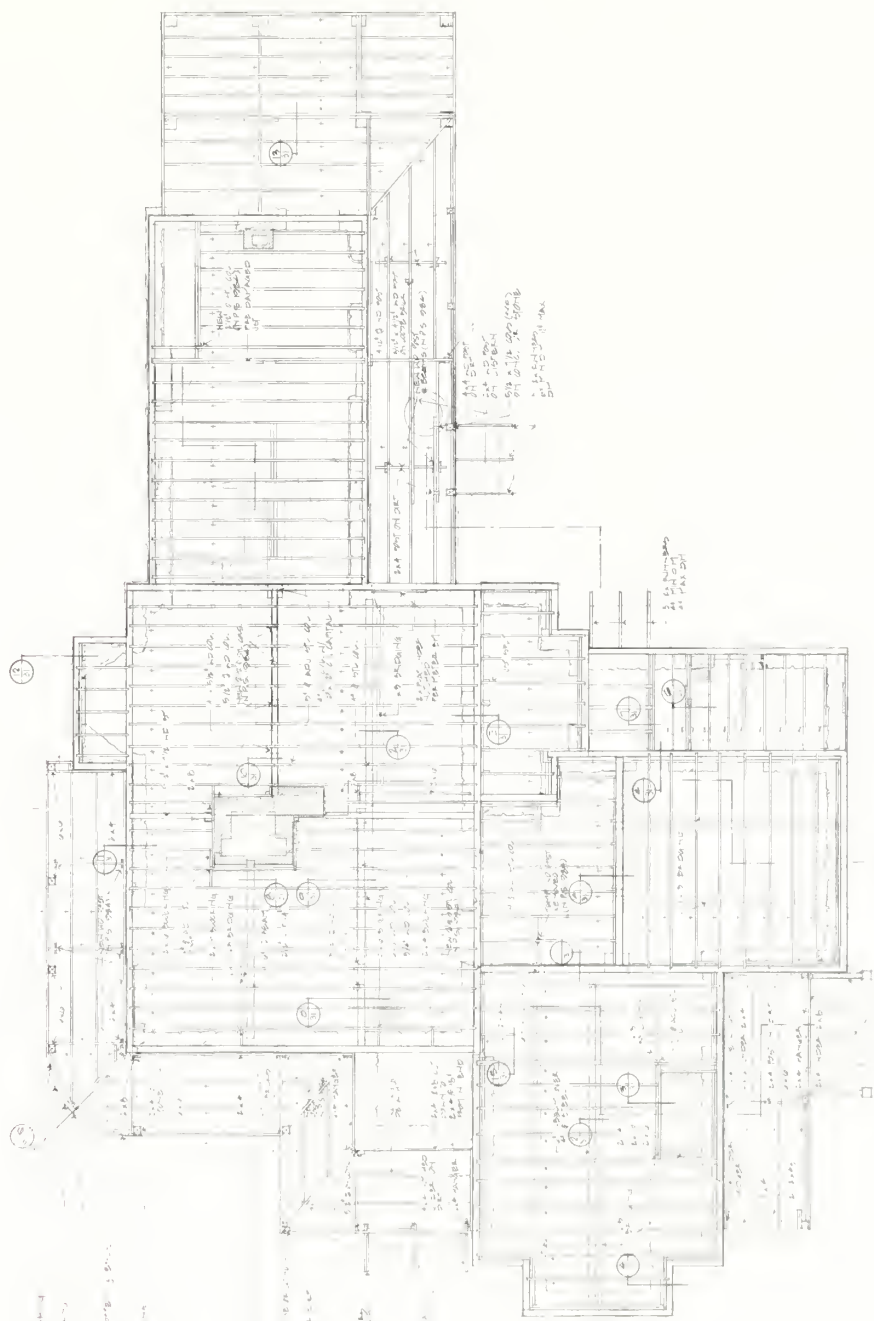
1 FIRST FLOOR FRAMING PLAN

The floor of the dining area (110) has been strengthened with the addition (c. 1940s-1950s) of a 6 inch steel I-beam at approximately mid-span of the floor joists. (See Existing Condition Drawings, No. 9, First Floor Framing Plan.) This steel beam has helped the loading capability within the southern section of the room; however, the controlling factor for resisting loading is the reduced shear capacity of the floor joists due to the notched bearing ends. They are set into pockets cut into both sides of the central wood beam. (See Existing Condition Drawings, No. 31, Framing Details, Detail 10.) Two square wood posts at the western end and the recent installation (by the National Park Service in 1984) of two steel pipe columns, 2-1/2 inch in diameter, at the eastern end support the wood beam at intermediate points. The resultant reduction in span compensates for the diminished load capability of the double notched beam over its original longer span. The dining room extends to the south (over basement room 007) beyond the stone foundation wall which designates the southern limits of the framing distinguished by the 5 x 8 wood beams. This portion of the room is framed using a system similar in most of the southern section of the basement which will be discussed later in this report. The critical detail of this room, however, is not the typical detail but the connection of the floor joists supporting this portion of the dining room to the perimeter 5 x 8 wood beam of the northern area. This connection is made by notching the 2 x 8 floor joists to a three inch dimension and setting this notched end into a pocket cut in a 2 x 6 member nailed to the southern face of the perimeter 5 x 8 wood beam (See Existing

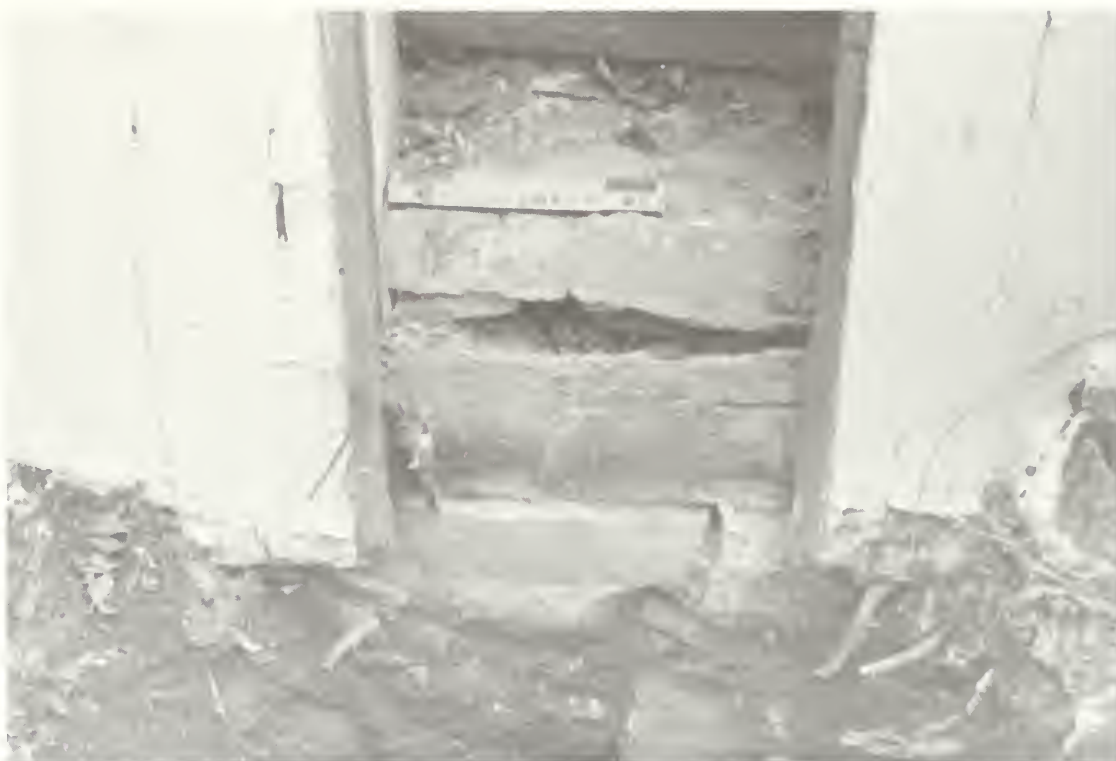
Fig. 3.5 Sill Beam at Post #17, Truman Carriage House. December 1985. West elevation. Credit: National Park Service, Midwest Region

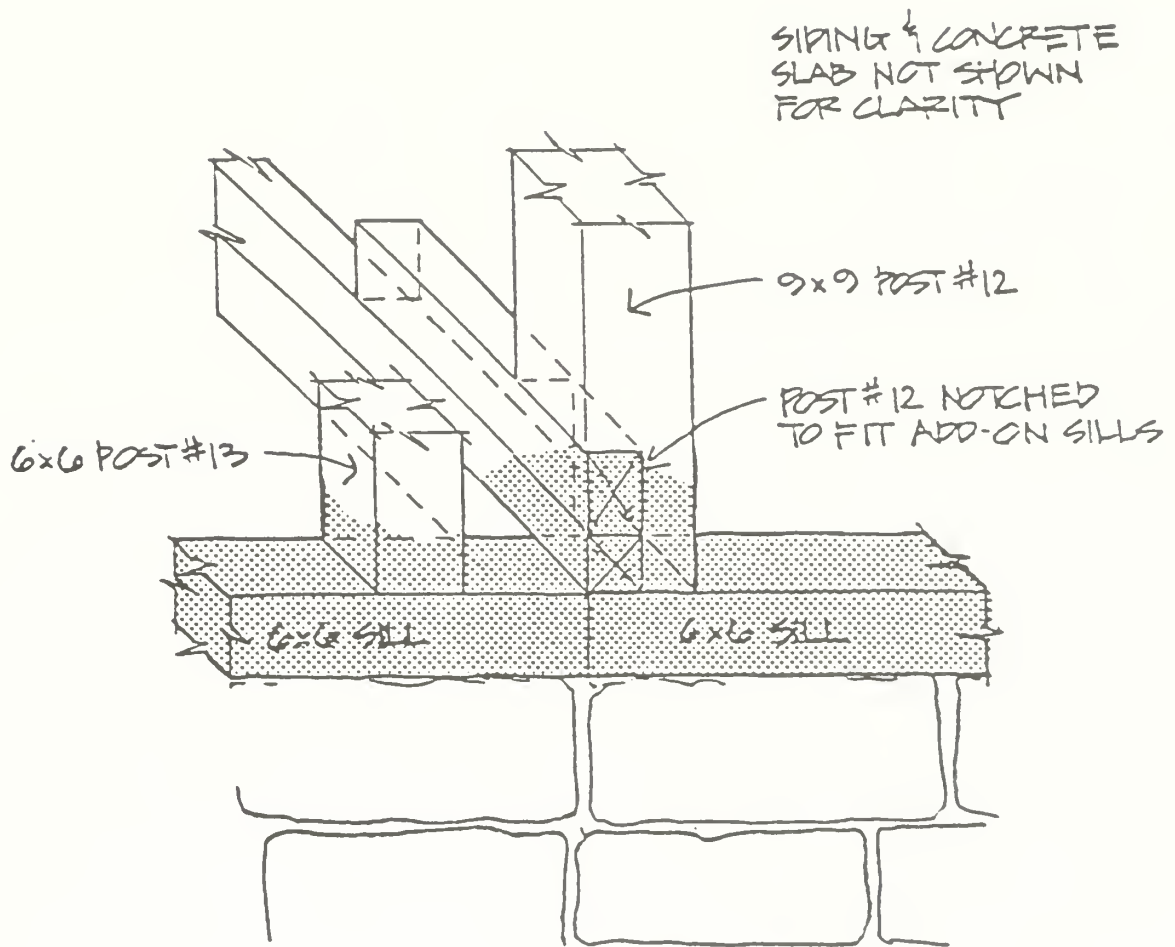
③ POST #12 DETAIL
SCALE ——— 1" = 1'-0"

DETERIORATION
